# Fidelity Home Inspections, LLC

## CONFIDENTIAL INSPECTION REPORT

1234 Ashi Blvd, Powder Springs, Georgia 30127

01/01/2005 9:00 am

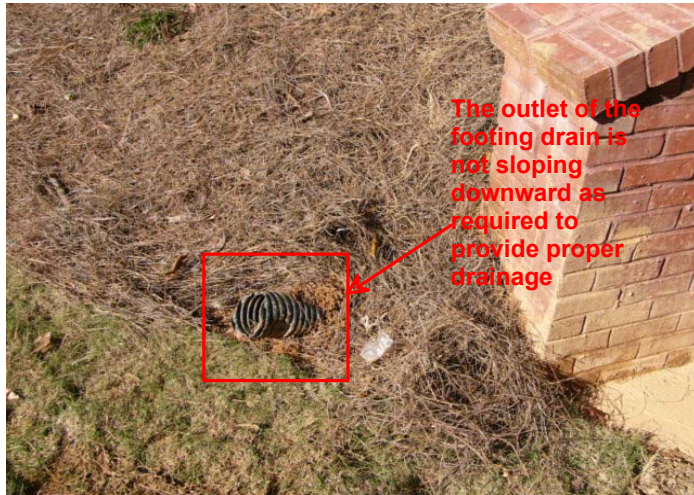
- 1.10 - The outlet of the footing drain is not sloping downward as required to provide proper drainage. These drains are installed to prevent damaging underground water from accumulating under the structural footings of the home. Improper drainage of the footings will lead to damaging structural settlement. An attempt should be made to adjust the grade to insure these drains have the proper downward slope.

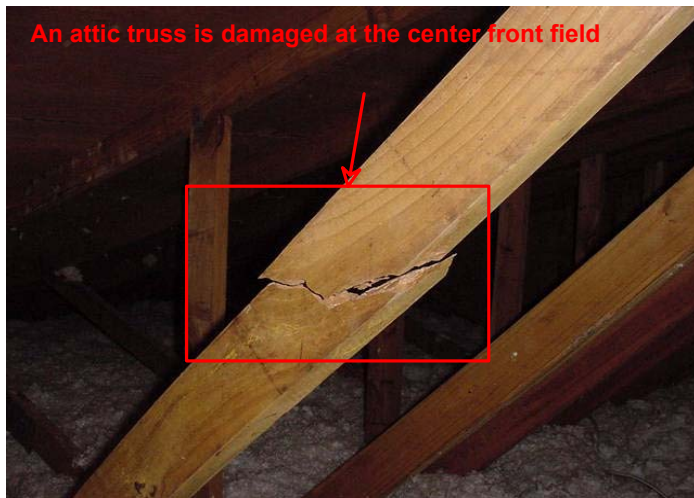
1.11 - An attic truss is damaged at the center front field. Trusses are engineered components used to provide a foundation for the roof. Their construction is pre-fabricated and they are designed to provide structural support by being plumb, and without changes to their configuration. Truss members shall not be cut, notched, drilled, spliced or otherwise altered in any way without the approval of a registered design professional. Further evaluation for repairs and follow up by a registered design professional is recommended.

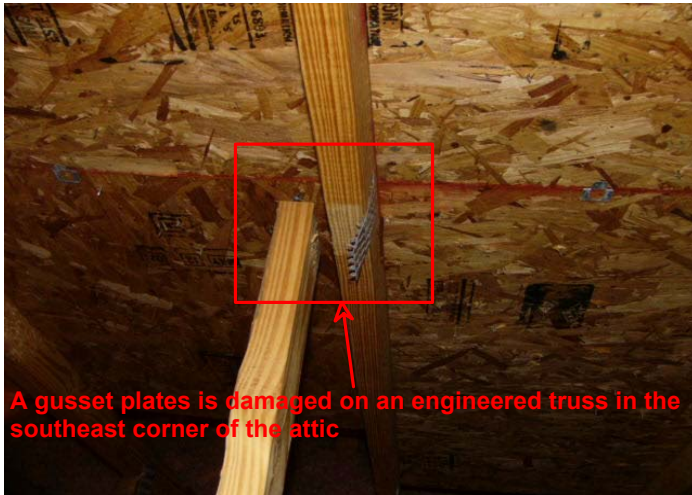
1.12 - A gusset plates is damaged on an engineered truss in the southeast corner of the attic. The gusset plates that hold them together should always be tight and undamaged. Trusses are engineered components used to provide a foundation for the roof. Their construction is pre-fabricated and they are designed to provide structural support by being plumb, and without changes to their configuration. Truss members shall not be cut, notched, drilled, spliced or otherwise altered in any way without the approval of a registered design professional. Further evaluation for repairs and follow up by a registered design professional is recommended.

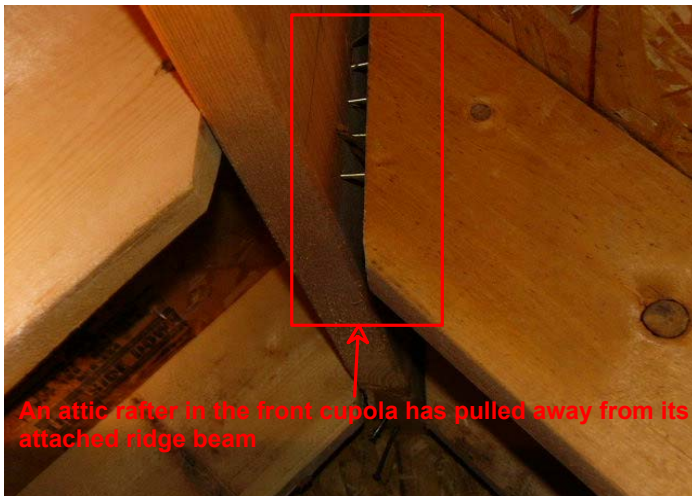
1.13 - An attic rafter in the front cupola has pulled away from its attached ridge beam. These rafters are structural components of the home. Their entire end cuts should always fully attached the ridge beam. An attempt should be made to determine why this rafter is in this condition. Further evaluation by a licensed contractor familiar with residential structures is recommended

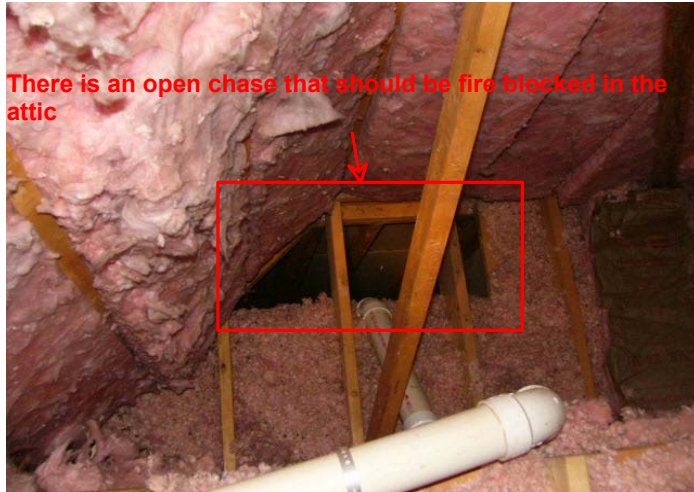
1.14 - There is an open chase that should be fire blocked in rear section of the attic . A chase is a concealed area between floors that provides a path for vents, pipes, ducts, chimneys, wiring or other utilities to other levels of the home. All openings of these chases should be properly sealed (fire blocked) with a non-combustible material to slow the spread of fire throughout the home. Fireblocking is a means of reducing the size of the large openings. Extra minutes and seconds can be a lifesaver in the event evacuation from fire should ever be necessary.

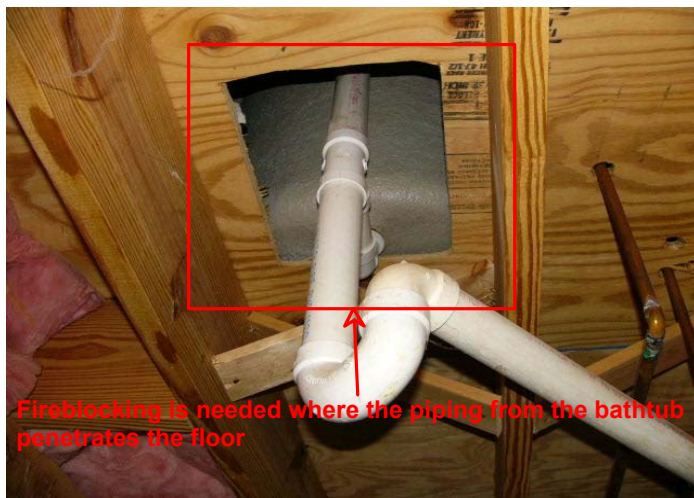
1.15 - Fireblocking is needed where the piping from the bathtub penetrates the floor. All concealed openings between floors that could provide a path for hot gasses and fire should be properly sealed (fire blocked) with a non-combustible material to slow the spread of fire throughout the home. Fireblocking is a means of reducing the size of the large openings around these pipes. Extra minutes and seconds can be a lifesaver in the event evacuation from fire should ever be necessary.

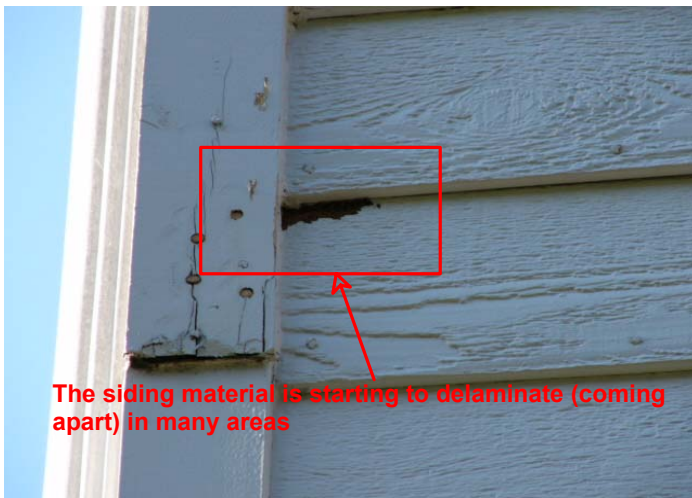
2.21 - The siding material is starting to delaminate (coming apart) in many areas. Localized repairs, replacement and/or painting may extend the life of the siding. Replacement may eventually be necessary - a significant expense.

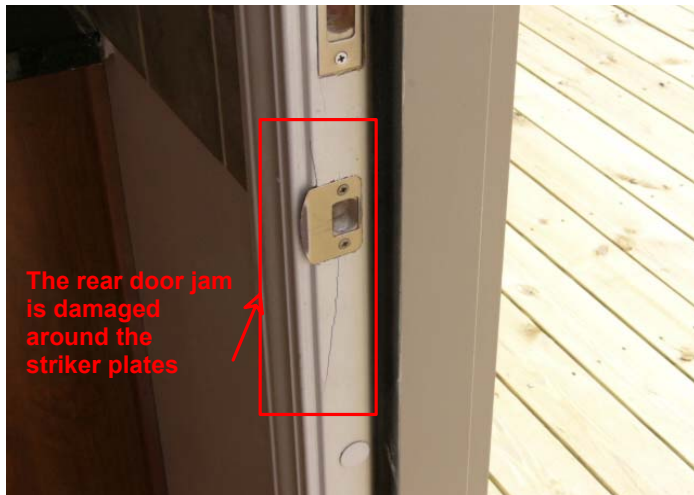
2.22 - The rear door jam is damaged around the striker plates. Damages such as this are usually from heavy loads being placed on the center section of the door. This damage has weakened the door jam assembly, which in turns weakens the security of the door. Recommend a licensed carpenter make repairs.

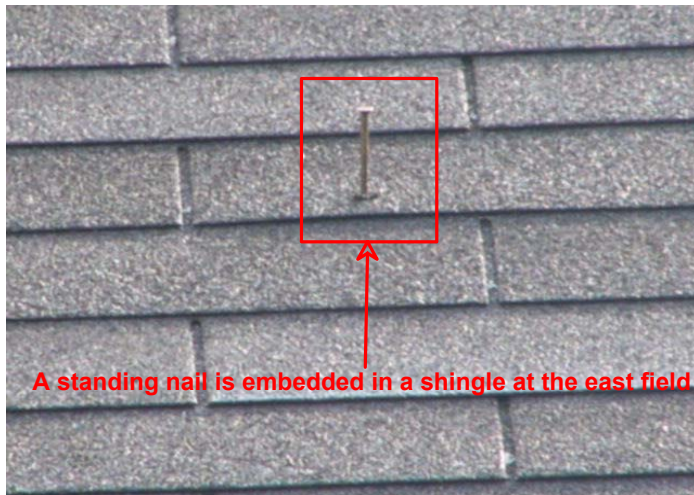
3.8 - A standing nail is embedded in a shingle at the east field. To prevent a roof leak, this nail should be removed and the hole its presence has made should be patched.

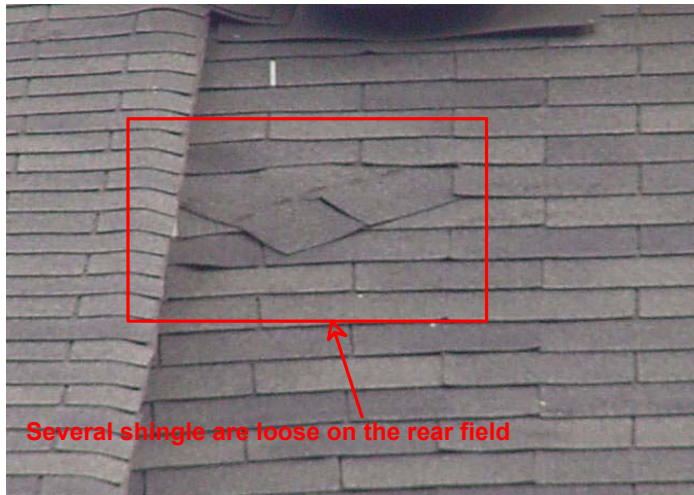
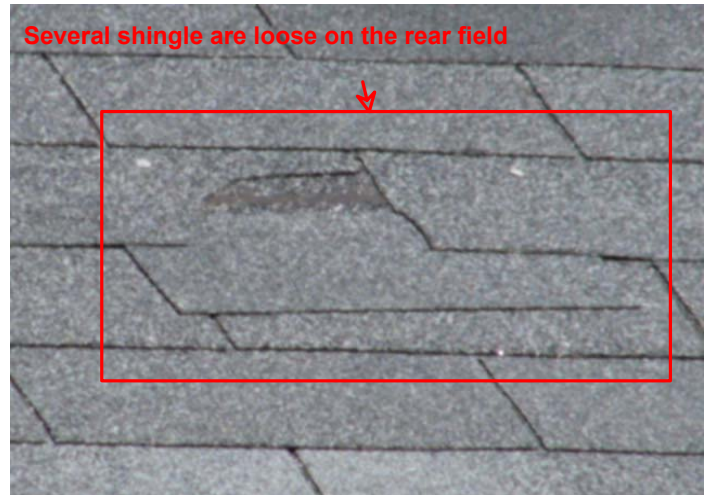
3.9 - Several shingle are loose on the rear field. Not only have they lost their ability to prevent damaging water from entering the home, high winds could blow them off the roof and cause more damage to the surrounding shingles. These shingles should not be in this condition if they were properly attached. Further evaluation by a licensed roofing contractor is recommended.

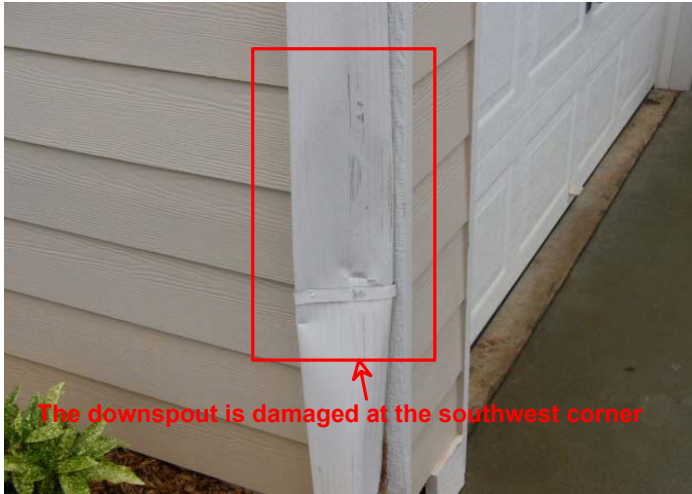
3.12 - The downspout is damaged at the southwest corner. This condition could trap debris from the roof causing a blockage of water in the downspout and cause overflowing gutters. This should be avoided as uncontrolled water can lead to foundation settlement and water entry into basements.

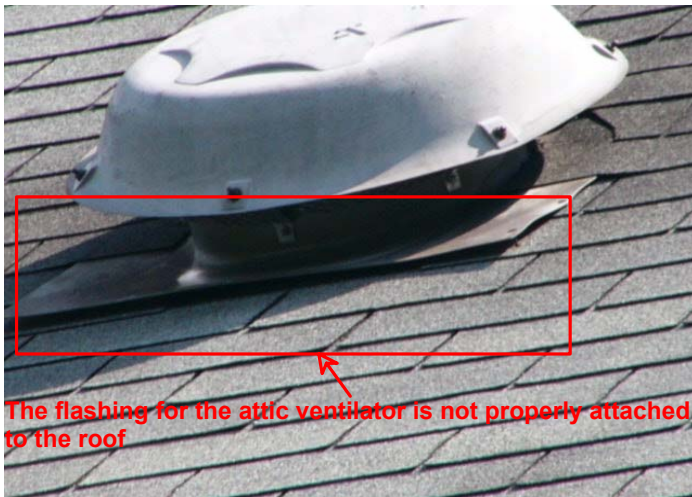
3.14 - The flashing for the attic ventilator is not properly attached to the roof. Nails are needed at the toe of the flashing to keep it from elevating upwards. Once this flashing is elevated, wind driven rain can find its way under the flashing and into the interior sections of the home. The same wind could also damage the flashing and its neighboring shingles. Recommend this flashing be properly attached to the roof.

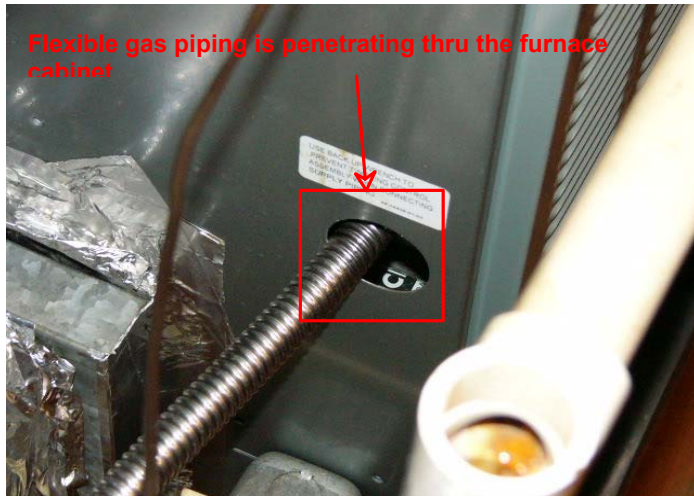
4.22 - Flexible gas piping is penetrating thru the furnace cabinet. There is always a slight vibration associated with an operating furnace. This vibration will help the raw metal edges of the furnace cabinet wear a hole in this flexible pipe and cause a gas leak. Gas leaks in the close proximity of the burner flame inside the furnace could

cause an explosion. Good construction practices, and plumbing codes in many jurisdictions require this section of gas pipe be hard steel pipe.

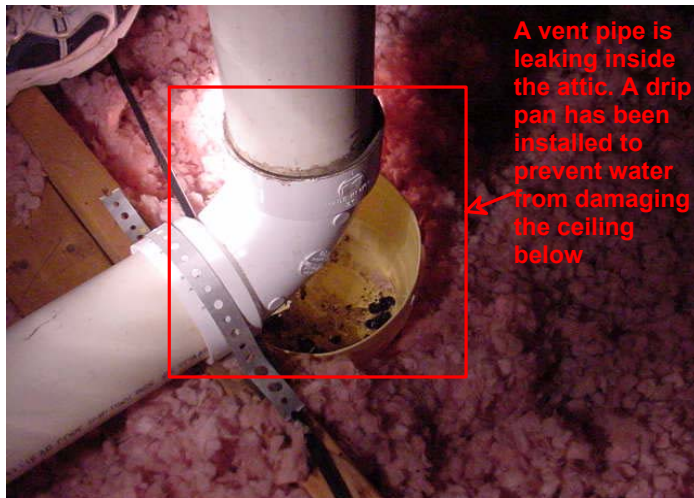
4.23 - A vent pipe is leaking inside the attic. A drip pan has been installed to prevent water from damaging the ceiling below. Recommend this leak be repaired before expensive ceiling repairs are needed.

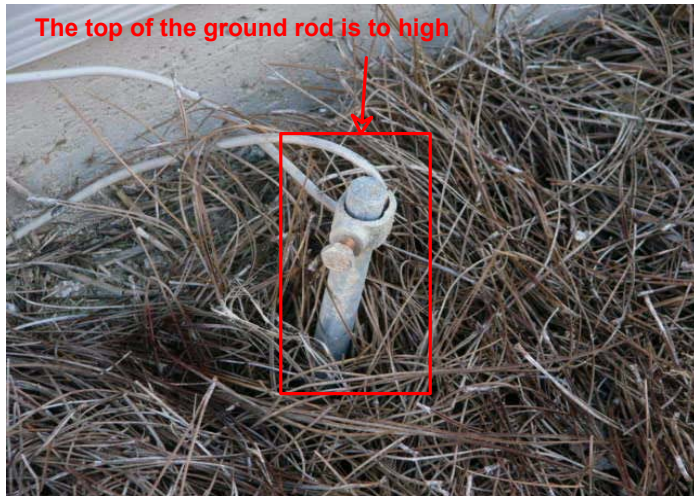
- 5.21 - The top of the ground rod is too high. A ground rod is an 8 foot metal shaft driven into the ground. Its purpose is to provide additional electrical safety. Ground rods shall be installed so that at least 8 feet of length is in contact with the soil. The upper end of the electrode shall be flush with, or below ground level unless the above ground end and the grounding wire clamp is protected against physical damage. Electrical grounding components are a critical safety component for the electrical system and its protection should be improved.

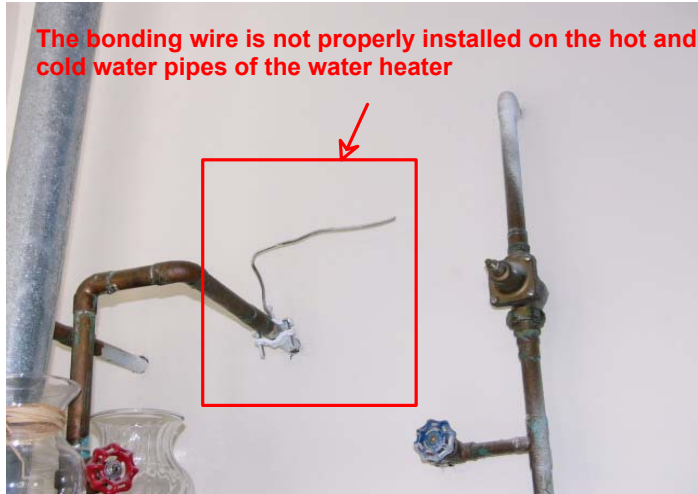
- 5.22 - The bonding wire is not properly installed on the hot and cold water pipes of the water heater. Conditions like this create electrical hazards to the occupants of the home.

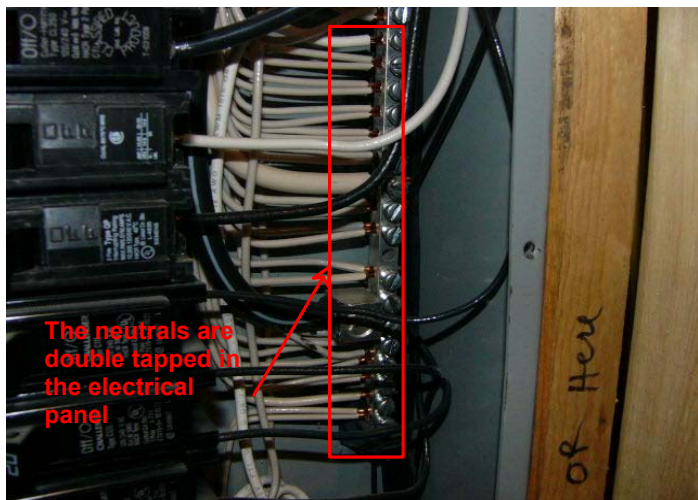
5.23 - The neutrals are double tapped in the electrical panel. The connectors on this type of panel are not designed to support two wires. Each grounded conductor shall terminate within the panel board in an individual terminal that is not also used for another conductor

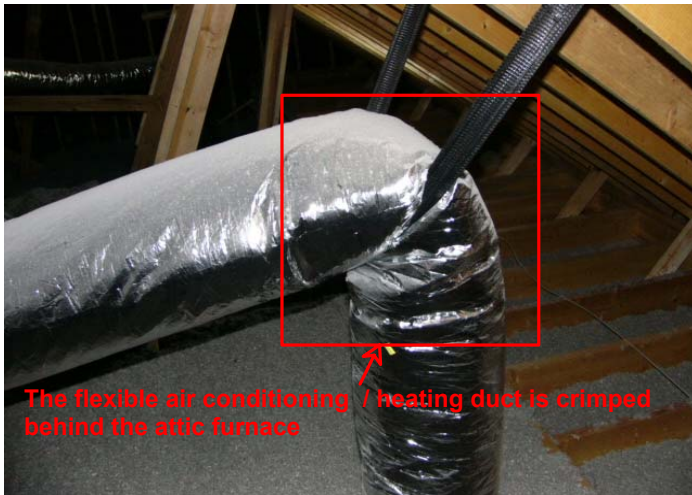
6.13 - The flexible air conditioning / heating duct is crimped behind the attic furnace. This condition will restrict the flow of conditioned air through the duct and into the room. Reduced airflow will reduced the efficiency of the heating / cooling system. Recommend a licensed heating / air conditioning contractor be retained to evaluate and repair.

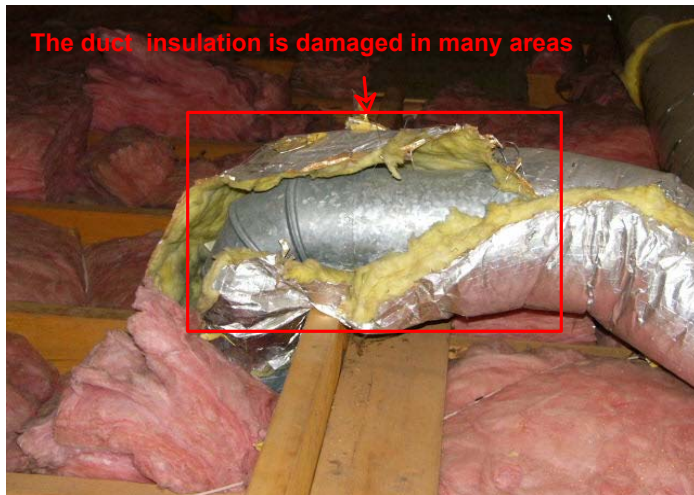
6.14 - The duct insulation is damaged in many areas. Insulation is needed to prevent the duct from sweating when the cooling system is used.

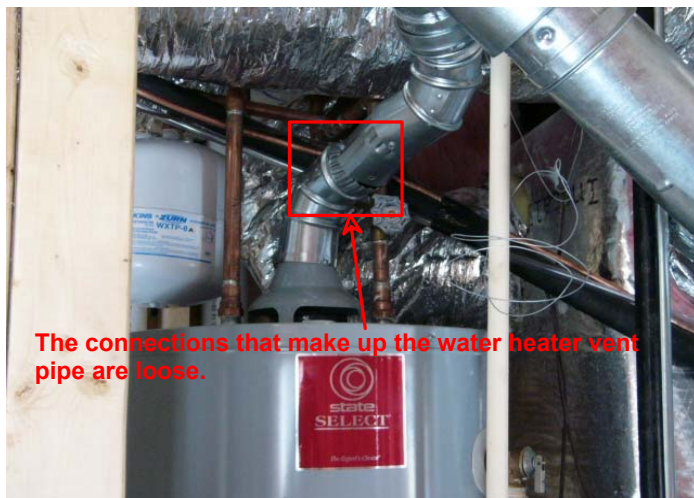
6.15 - The connections that make up the water heater vent pipe are loose. This is a serious condition that could be a carbon monoxide health threat to the occupants of the home. Repairs should be made by licensed and qualified contractors.

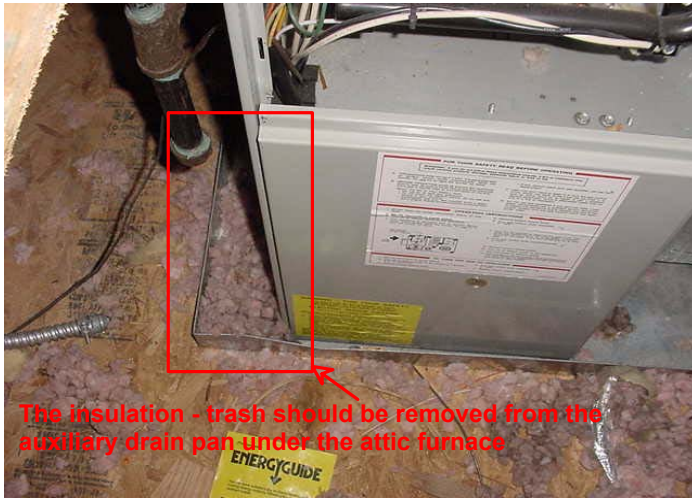
7.11 - The insulation - trash should be removed from the auxiliary drain pan under the attic furnace. This drain pan is installed to catch overflowing condensate water in the event the main condensate line stops up. A clean pan will reduce the potential for water damage to areas under the unit.

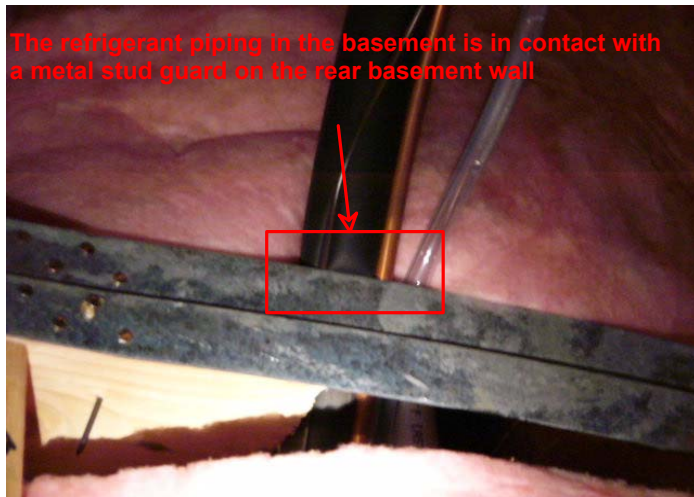
7.12 - The refrigerant piping in the basement is in contact with a metal stud guard on the rear basement wall. These pipes vibrate when the system is in use. Continued contact with these metal plates will eventually wear a hole into the refrigerant pipe and cause a condition that would necessitate a major costly repair. Recommend these pipes be shielded from these protective plates and any other metals before the drywall is installed.

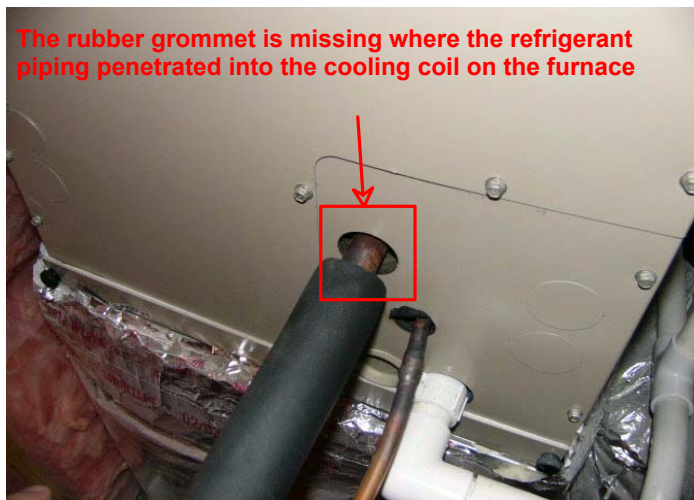
7.13 - The rubber grommet is missing where the refrigerant piping penetrated into the cooling coil on the furnace. This grommet is used to prevent the cold pipes from exposure to conditions that will cause sweating. Sweating pipes is a source of unwanted damaging moisture to surrounding areas.

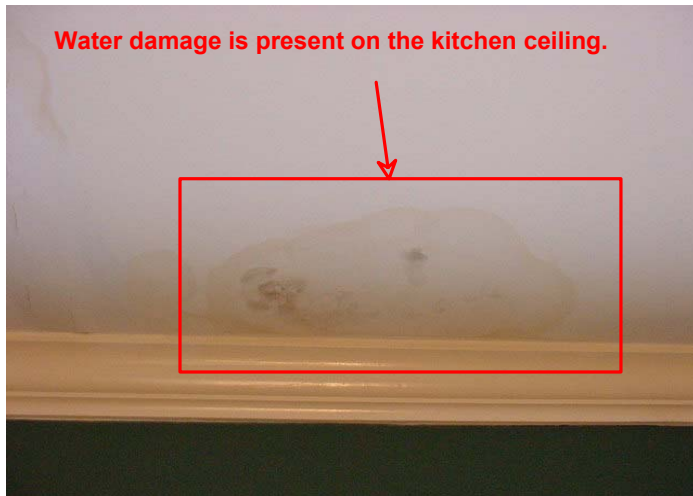
8.16 - Water damage is present on the kitchen ceiling. This area is under a bathroom. Water damages under bathrooms are usually the result of leakage from a plumbing fixture above. The concern is, the source of this water damaged is concealed and its location, history and current condition is not known. Only a destructive inspection will find the water leak and its current condition. This type of inspection will require the removal of the damaged ceiling and tracing the source of the water. Further evaluation by a licensed plumbing contractor is recommended.

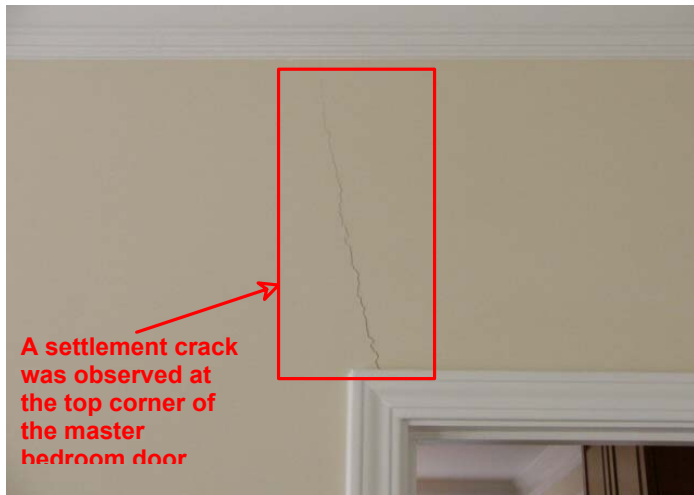
8.17 - A settlement crack was observed at the top corner of the master bedroom door. Cracks like this show movement has occurred in the structural framing of the home. This movement may be a one time move or it could be an active condition. This can only be determined by monitoring the size of the crack and the areas around it for further movement. If continued activity is present, the services of a structural engineer may be needed.
