Fidelity **Home Inspections, LLC**

CONFIDENTIAL INSPECTION REPORT PREPARED FOR: **Jane Smith**

INSPECTION ADDRESS
1234 Ashi Blvd, Powder Springs, Georgia 30127

INSPECTION DATE
01/01/2005 9:00 am

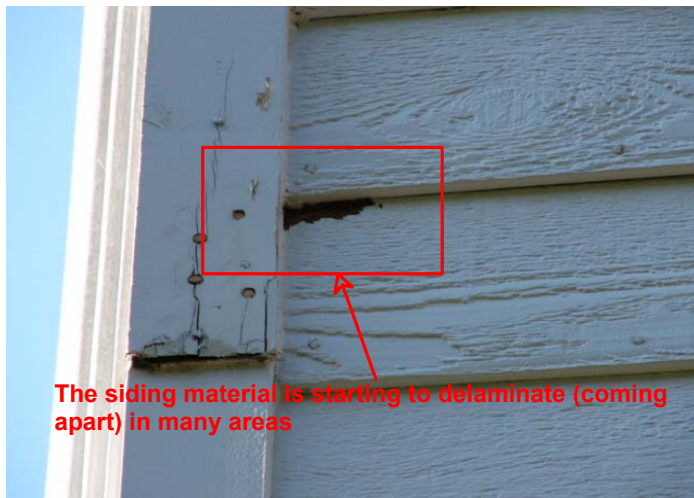
2.21 - The siding material is starting to delaminate (coming apart) in many areas. Localized repairs, replacement and/or painting may extend the life of the siding. Replacement may eventually be necessary - a significant expense.

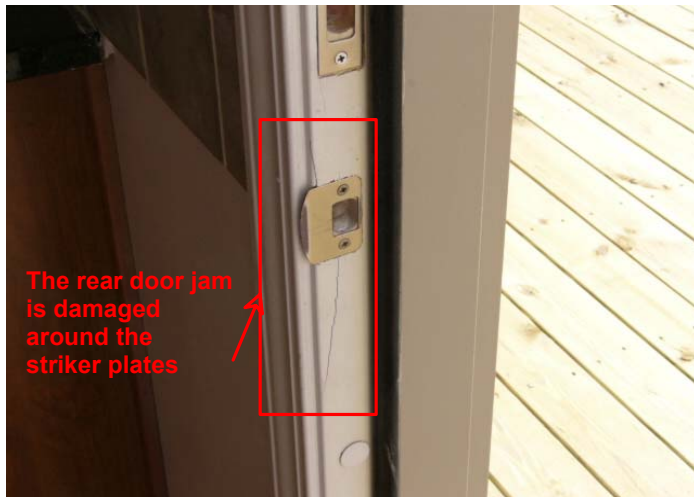
2.22 - The rear door jam is damaged around the striker plates. Damages such as this are usually from heavy loads being placed on the center section of the door. This damage has weakened the door jam assembly, which in turns weakens the security of the door. Recommend a licensed carpenter make repairs.

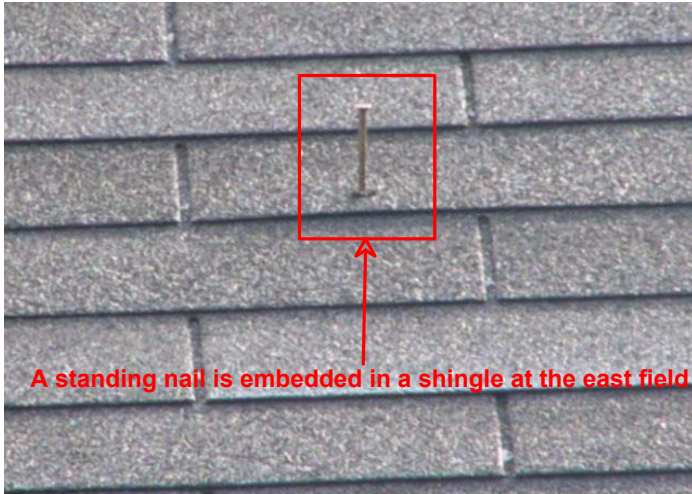
3.8 - A standing nail is embedded in a shingle at the east field. To prevent a roof leak, this nail should be removed and the hole its presence has made should be patched.

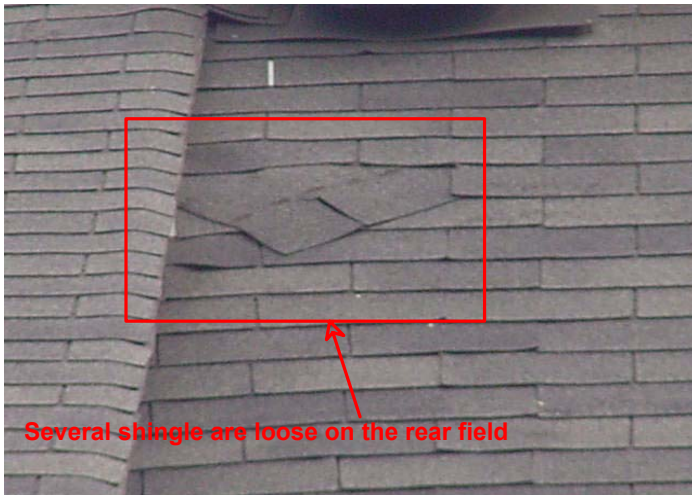
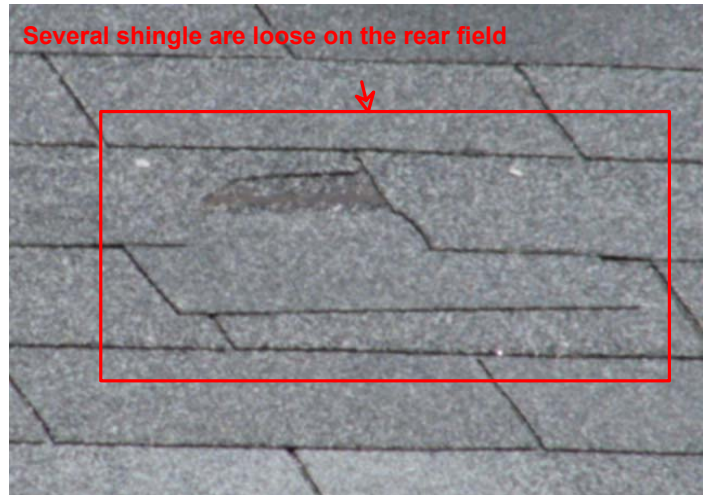
3.9 - Several shingle are loose on the rear field. Not only have they lost their ability to prevent damaging water from entering the home, high winds could blow them off the roof and cause more damage to the surrounding shingles. These shingles should not be in this condition if they were properly attached. Further evaluation by a licensed roofing contractor is recommended.

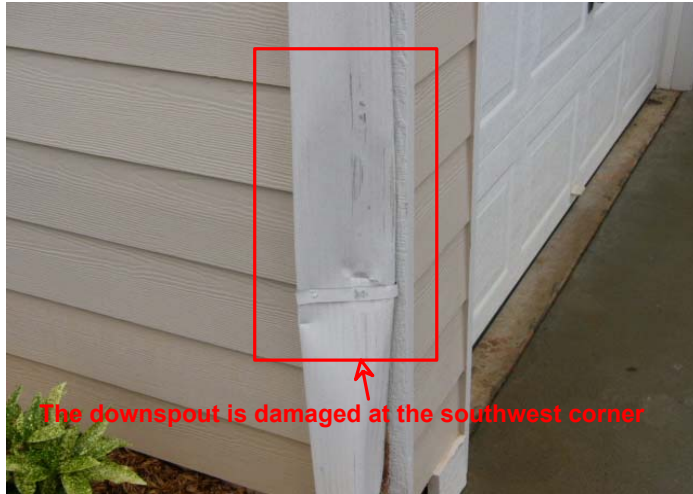
3.12 - The downspout is damaged at the southwest corner. This condition could trap debris from the roof causing a blockage of water in the downspout and cause overflowing gutters. This should be avoided as uncontrolled water can lead to foundation settlement and water entry into basements.

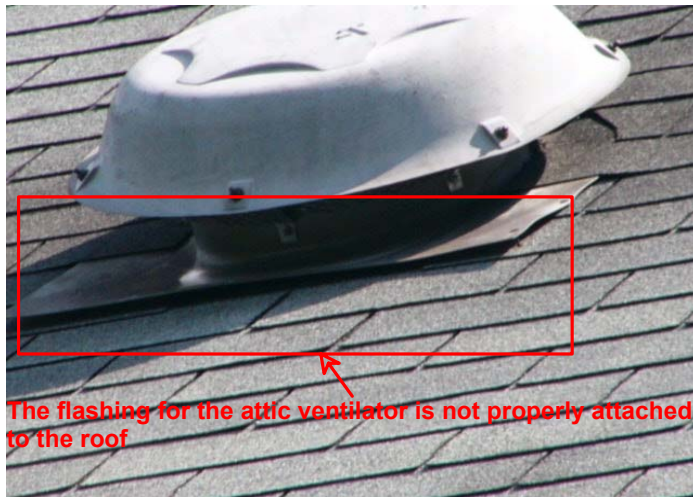
3.14 - The flashing for the attic ventilator is not properly attached to the roof. Nails are needed at the toe of the flashing to keep it from elevating upwards. Once this flashing is elevated, wind driven rain can find its way under the flashing and into the interior sections of the home. The same wind could also damage the flashing and its neighboring shingles. Recommend this flashing be properly attached to the roof.

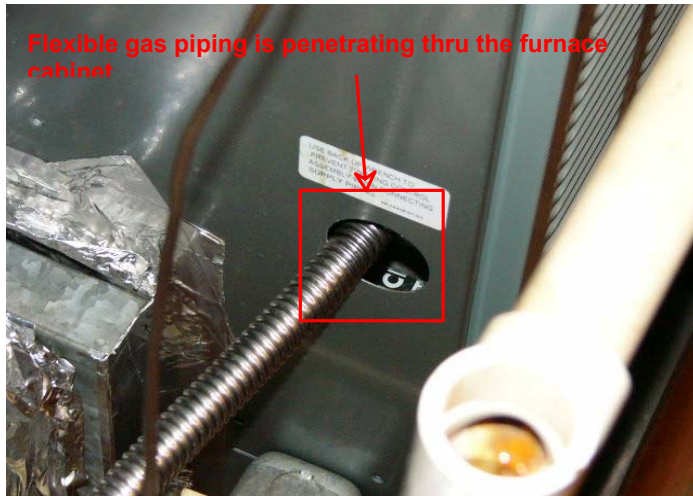
4.22 - Flexible gas piping is penetrating thru the furnace cabinet. There is always a slight vibration associated with an operating furnace. This vibration will help the raw metal edges of the furnace cabinet wear a hole in this flexible pipe and cause a gas leak. Gas leaks in the close proximity of the burner flame inside the furnace could

cause an explosion. Good construction practices, and plumbing codes in many jurisdictions require this section of gas pipe be hard steel pipe.

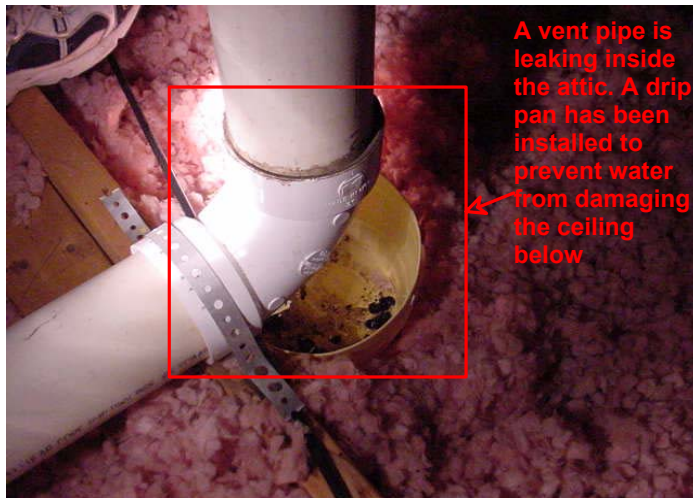
4.23 - A vent pipe is leaking inside the attic. A drip pan has been installed to prevent water from damaging the ceiling below. Recommend this leak be repaired before expensive ceiling repairs are needed.

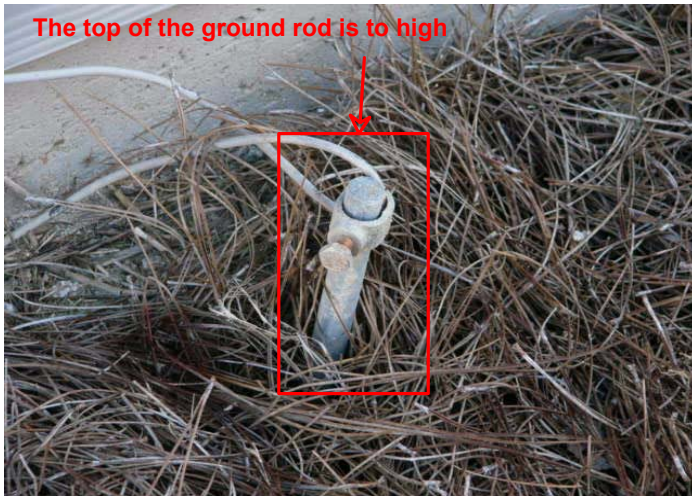
- 5.21 - The top of the ground rod is too high. A ground rod is an 8 foot metal shaft driven into the ground. Its purpose is to provide additional electrical safety. Ground rods shall be installed so that at least 8 feet of length is in contact with the soil. The upper end of the electrode shall be flush with, or below ground level unless the above ground end and the grounding wire clamp is protected against physical damage. Electrical grounding components are a critical safety component for the electrical system and its protection should be improved.

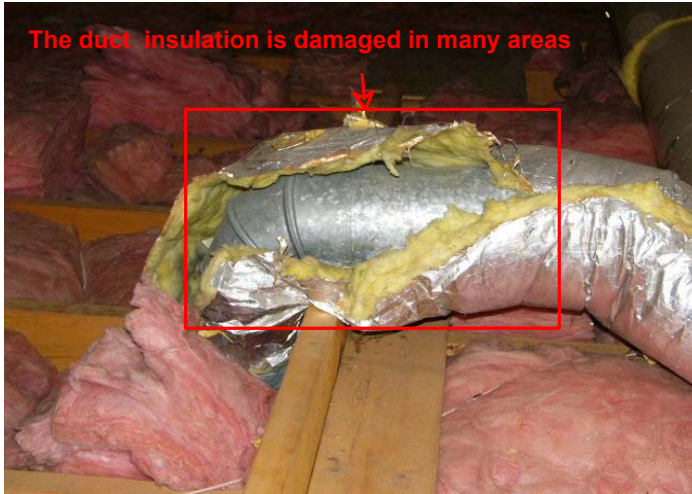
6.14 - The duct insulation is damaged in many areas. Insulation is needed to prevent the duct from sweating when the cooling system is used.

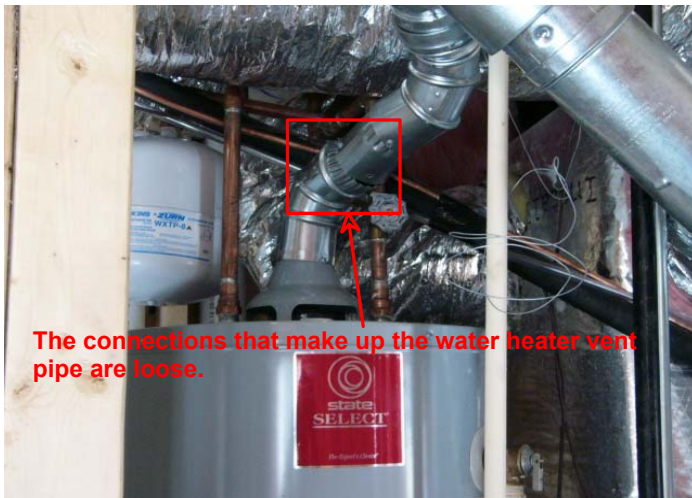
6.15 - The connections that make up the water heater vent pipe are loose. This is a serious condition that could be a carbon monoxide health threat to the occupants of the home. Repairs should be made by licensed and qualified contractors.

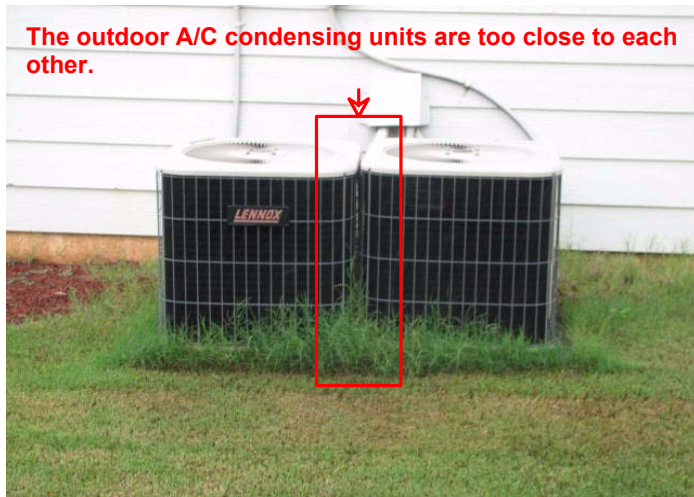
7.11 - The outdoor A/C condensing units are too close to each other. This condition is preventing proper airflow through the coils. When positioning an outdoor A/ C condensing unit, it is important to allow a minimum of 10" clearance between any wall, or other obstruction, and the coils on the sides of the unit. The airflow through these coils must never be restricted or the compressor may overheat and have a dramatically decreased lifetime. The designed efficiency of the cooling system will also be reduced resulting in higher power bills. A licensed heating / cooling contractor should be retained to further evaluate and recommend a corrective course of action.

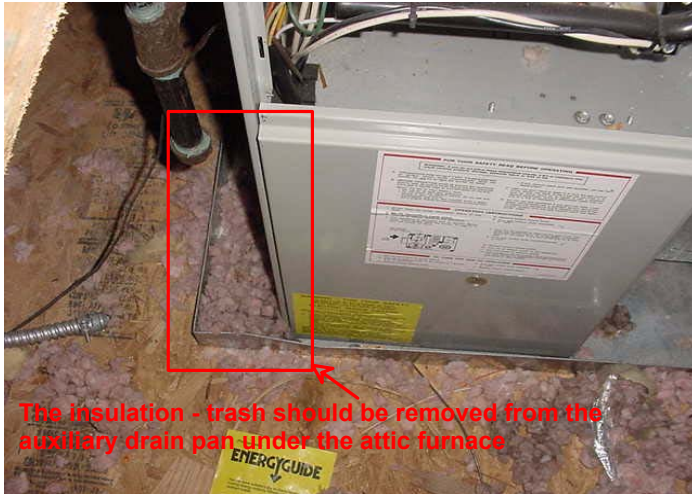
7.12 - The insulation - trash should be removed from the auxiliary drain pan under the attic furnace. This drain pan is installed to catch overflowing condensate water in the event the main condensate line stops up. A clean pan will reduce the potential for water damage to areas under the unit.

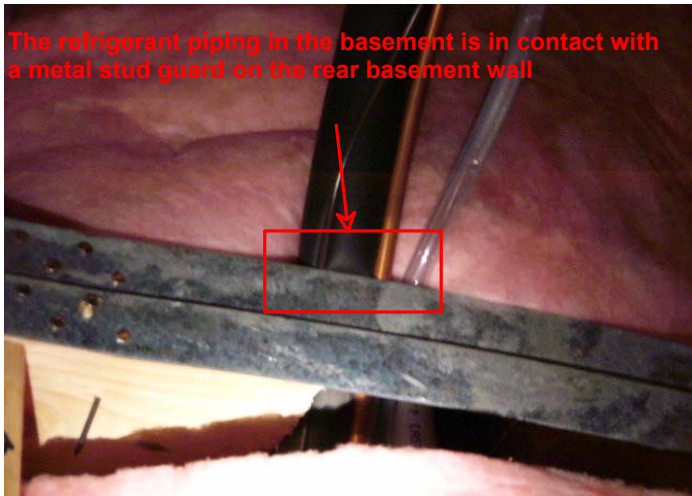
7.13 - The refrigerant piping in the basement is in contact with a metal stud guard on the rear basement wall. These pipes vibrate when the system is in use. Continued contact with these metal plates will eventually wear a hole into the refrigerant pipe and cause a condition that would necessitate a major costly repair. Recommend these pipes be shielded from these protective plates and any other metals before the drywall is installed.

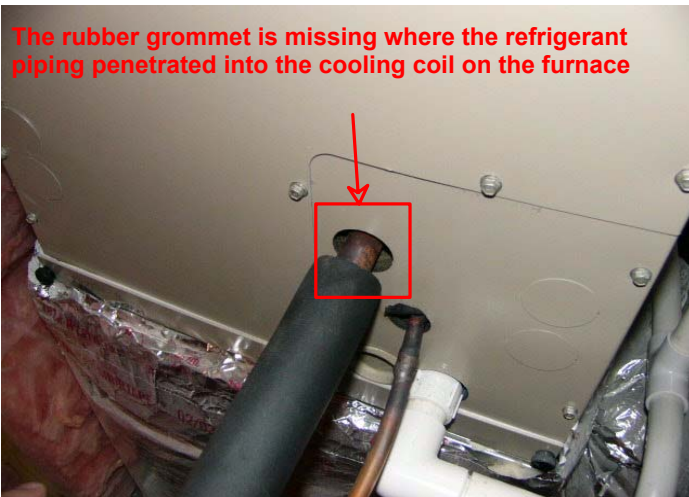
7.14 - The rubber grommet is missing where the refrigerant piping penetrated into the cooling coil on the furnace. This grommet is used to prevent the cold pipes from exposure to conditions that will cause sweating. Sweating pipes is a source of unwanted damaging moisture to surrounding areas.
